Restorations in post-war period

monument care, post-war restorations, modernist reconstruction, Chudomelka

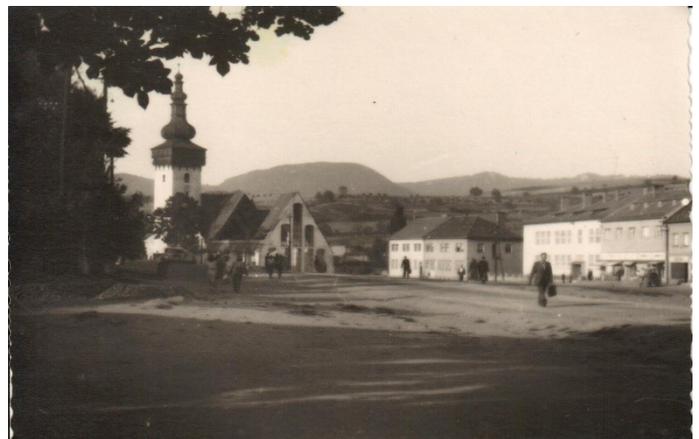
Figure 1: The Handlová Church after the intervention of Rudolf Schwarz in 1942 – 1943, state before war devastation.
Source: Personal archive of Jozef Maďar

Perhaps the largest construction intervention took place during the Second World War, when in the years 1942 – 1943 a transept was added to the main nave, the width of which occupied the entire length of the original nave. (Fig. 1). The main altar was located in the middle of the crossing of naves. During this rebuilding, the renaissance vaults of the church were preserved, and openings in the side walls of the original nave were broken to connect both naves. The beamed ceiling of the new extension was positioned at a higher level from the top of the vaults. The rebuilding idea originated from the German professor Rudolf Schwarz from Frankfurt am Main and significantly changed the historical proportions of the church and its position in relation to the cardinal directions.

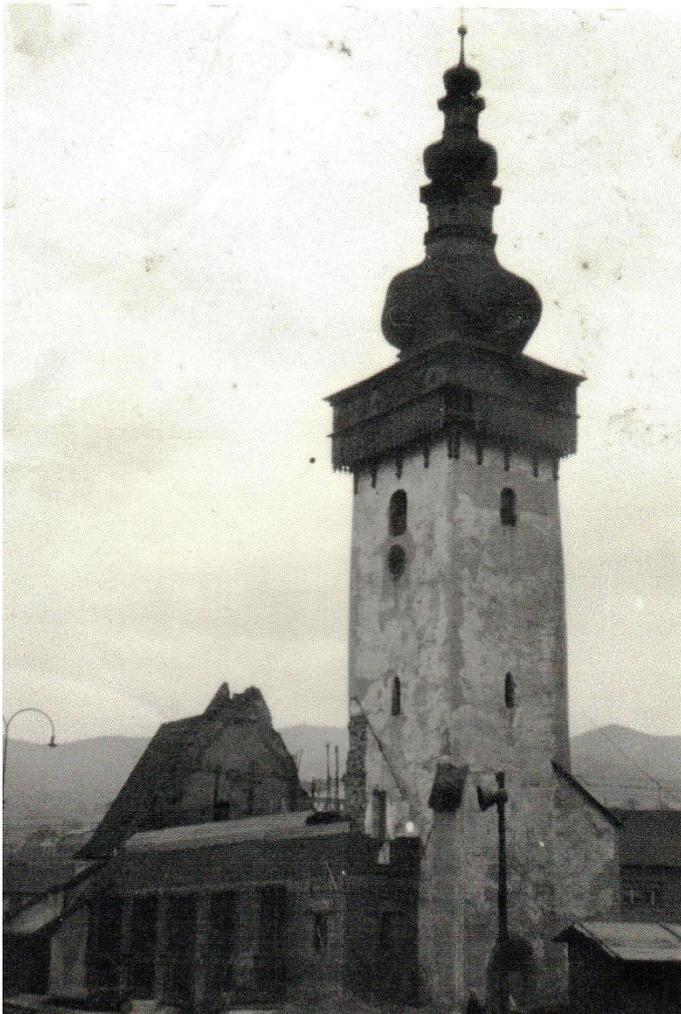
Figure 2: State of The Handlová Church before restoration.
Source: Archive of the Church of St. Catherine of Alexandria in Handlová, Slovakia

The church was significantly damaged at the end of the war in 1945 by air bombs, when almost the entire historic nave was destroyed. (Fig. 2) The tower and the presbytery have been preserved. Already in 1947, a project for the restoration of the church was drawn up, commissioned to the architects František Bednárik and František Faulhammer. In their design, they followed the previous concept of development with a distinctive transept, however, with the altar located in the northern part of the nave and the restoration did not consider the preservation of the vaults. This design was not implemented. [7]

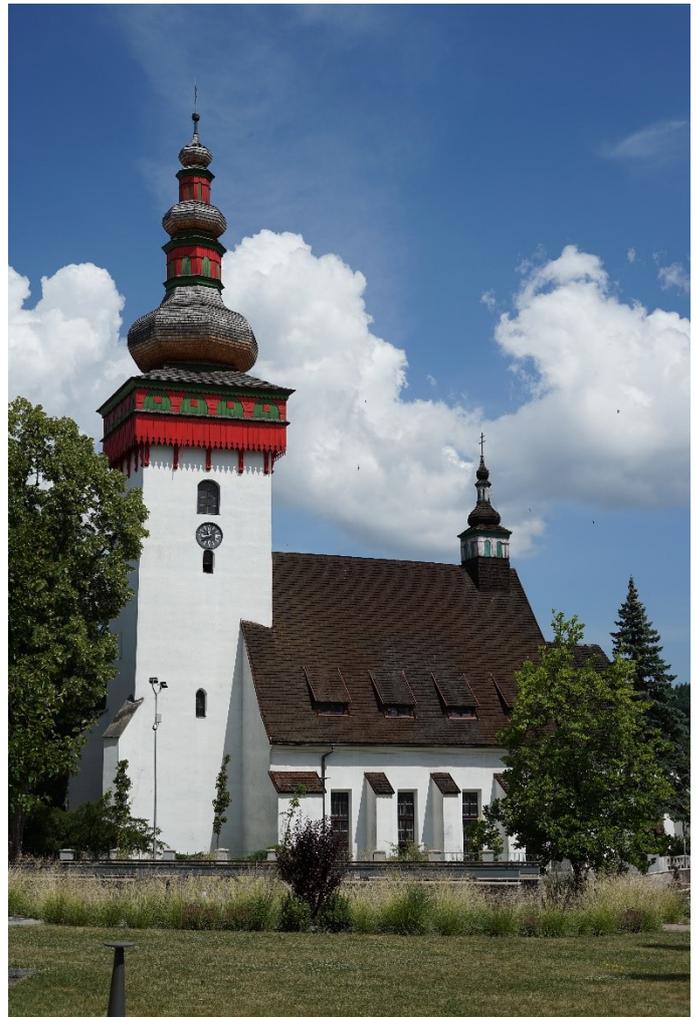
Figure 3: The current state of The Handlová Church.
Author: Martina Jelínková

Conservation was applied to all preserved parts of the building. Based on preserved and precisely identifiable imprints of the Gothic roof gable, the original beamed ceiling, and vaults, Chudomelka reconstructed the original historical volume of the church while preserving the height of the ridge and the slope of the Gothic roof. (Fig. 3) Due to the current demand of the investor to increase the capacity of the church, he designed the interior as a new three-nave building with multi-floor side and rear emporiums. (Fig. 4, 5, 6) The inserted new-creation interior was designed as a reinforced concrete skeleton typical of the post-war modernist period. Chudomelka roofed the raised middle nave with a reinforced concrete ceiling with diagonal ribs as an indicative reconstruction of the cross vault, thus clearly distinguishing it from the architect's contemporary interventions.

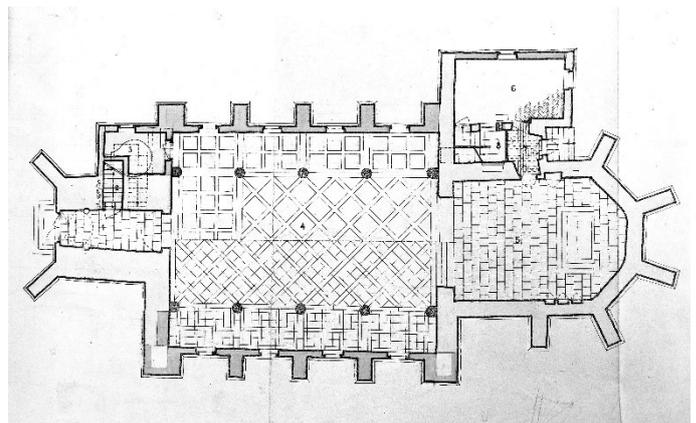
Figure 4: Floor plan, the current state of The Handlová Church.
Author: Karol Chudomelka
Source: Archive of The Monuments Board of the Slovak Republic

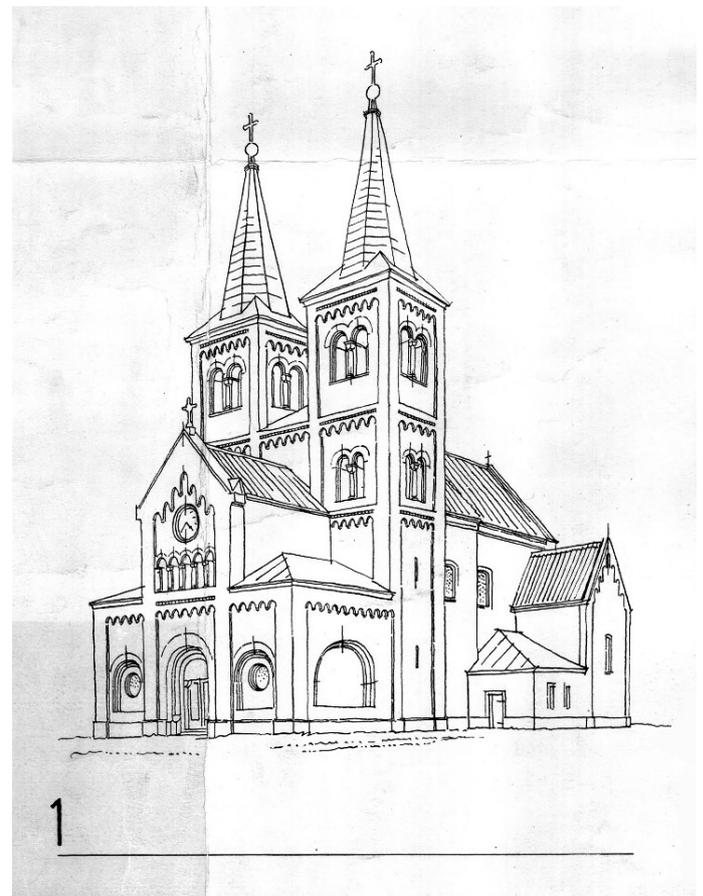
Figure 7: The Biňa Church after the intervention of Győző Czigler in 1896 – 1898, state before war devastation.
Author: Alfréd Piffli

The last change took place in the years 1896 – 1898, when the church was modified in a purist manner in the spirit of the pseudo-Romanesque style. (Fig. 7) The builder Gyözö Czigler was inspired by Hungarian churches from the same time period as the Church in Biňa. It was during this period that the original ground floor porch of the church was raised in its middle part. [8]

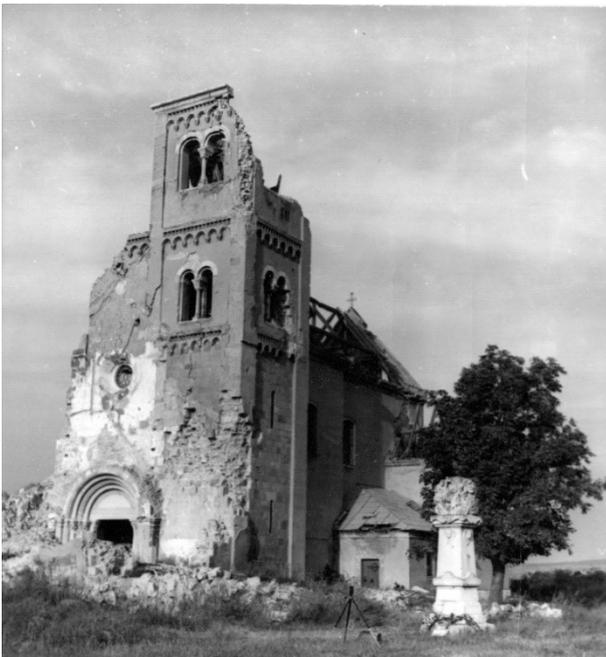
Figure 8: State of The Biňa Church before restoration.

As in the above example, this church was also devastated before the end of the Second World War, in March 1945. (Fig. 8) Although Alfréd Piffel was commissioned the restoration of the church in 1951, the authorship of the final form remains shrouded in mystery. [4] In the publication "Revived Monuments in the Work of the architect Karol Chudomelka", the author Zuzana Ševčíková mentions the church in Biňa as one of Chudomelka's first works. However, in our research we have discovered no more than measurements drawings of the church and drawing documentation for the rotunda [9], developed at that time by the architect Katarína Boudová, the future wife of Karol Chudomelka.

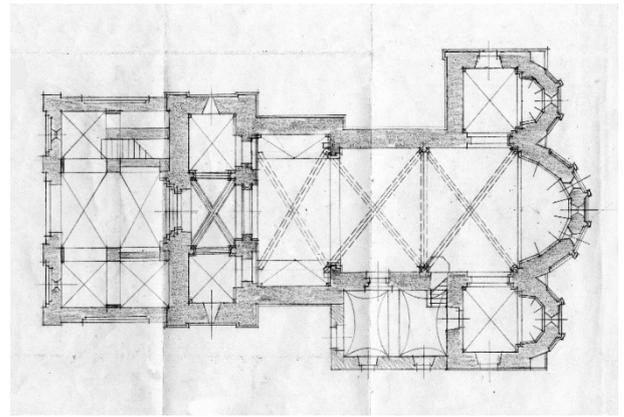
Figure 9: Floor plan, the current state of The Biňa Church.
Source: Archive of The Monuments Board of the Slovak Republic

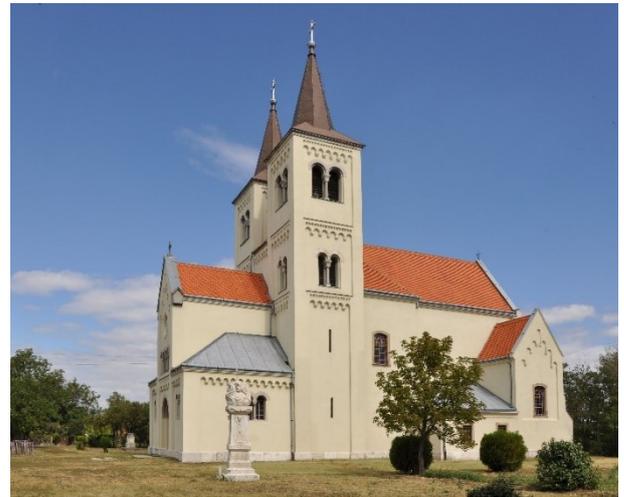
Figure 10: The current state of The Biňa Church.

Although we do not know the whole story of how and who decided on the final form of the monumental restoration of the church, we can say with certainty that the church was returned the state before its destruction and bears purist signs of intervention. The towers, as well as the porch with the elevated middle part and the vaults were reconstructed to the state before the destruction. The porch was given new arcaded windows in the neo-Romanesque style, which were not existing before the destruction. (Fig. 9, 10) Alfréd Piffel's original designs envisaged reducing the mass of the porch to its original level before the rebuilding in 1896 – 1898 and even proposing to roof the nave with a wooden beamed ceiling. [10]

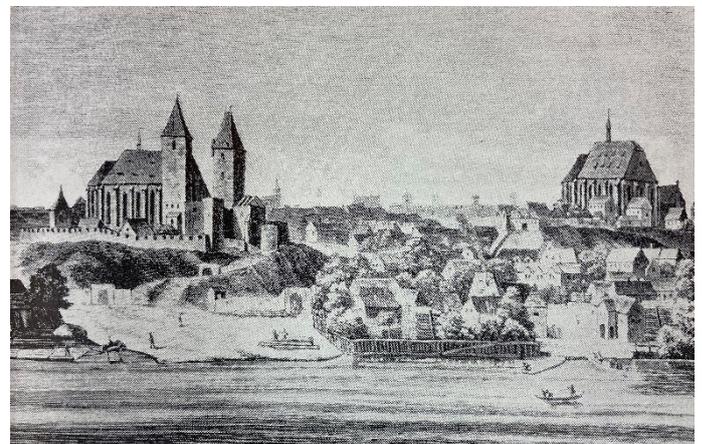
Figure 11: The Emmaus Church on the right in its original Gothic form.

Drawing by E. Herold according to Sadeler's prospectus from 1606.

The church as a part of the monastery complex of the Slavic Benedictines began to be built in 1347, commissioned by Emperor Charles IV. It was originally a three-nave hall church with an elevated middle nave. However, the entire substance of the church was transferred from the exterior to a uniform volume terminated by a massive, raised gable roof with a single vertical slender spire. **(Fig. 11)** The church was an exceptional Gothic building, the external form of which created a distinctive and urbanistic-wise very impressive accent of the city. **[11]**

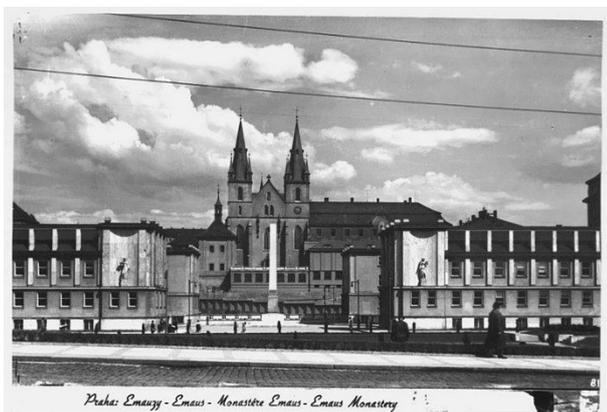
Figure 12: (Caption opposite)

Figure 12: The Emmaus Church after the intervention of Bohumil Hypšman in 1923 – 1924, state before war devastation.
 Author: Orbis (1900-1944)
 Source: National Heritage Institute, Prague, Czech Republic. Available at: https://iispp.npu.cz/mis_public/documentDetail.htm?id=1347429

In the years 1923 – 1924, the last building modification took place. This did not directly involve the monastery but urbanistically developed to consider its status quo at that time and later influenced the restoration of the church itself. It was the completion of a set of public buildings in the immediate vicinity of the monastery complex. **(Fig. 12)** The architect of this extension, Bohumil Hypšman, intensified the urban effect of the church with a symmetrical composition of his own intervention and thus created a significant accent in the locality from the western facade of the church. **[11]**

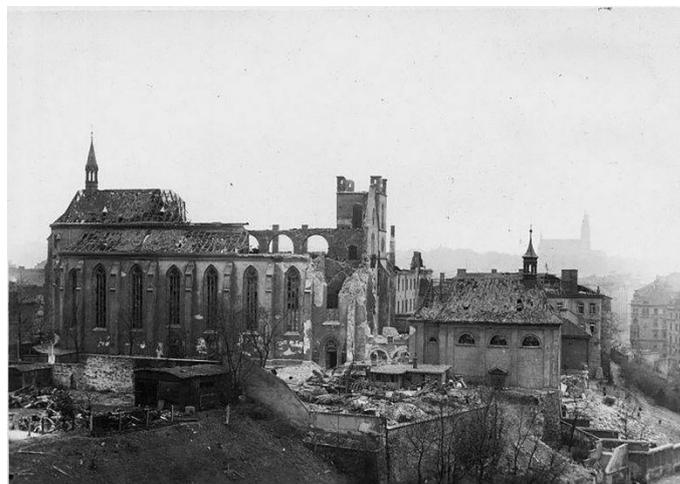
Figure 13: State of The Emmaus Church before restoration.
 Authors: Končinský, Tuháček (1945)
 Source: National Heritage Institute, Prague, Czech Republic. Available at https://iispp.npu.cz/mis_public/documentDetail.htm?id=1347423

The monastery complex was closed by the Nazis in 1942 and in February 1945 it was devastated during an American air raid on Prague (Czech Republic). The north tower of the church, the upper part of the south tower, the entire vault of the main nave, most of the vaults of the side naves and the truss of the church, and the monastery were destroyed. **(Fig. 13)** As in the cases discussed above, the restoration began relatively quickly after the end of the war. However, it lasted over two decades. The reason was the ambiguity in the restoration methodology, especially regarding the western facade. At that time, the professional public considered two ways of possible restoration, namely the restitution of the original Gothic form of the church or the reconstruction of the last preserved state before destruction. Necessary static and consolidation work was carried out on the monastery complex. The church was vaulted with reinforced concrete vaults, the walls were supported with reinforced concrete 'belts' and a new truss made of reinforced concrete trusses was designed. **(Fig. 14, 15)** This included mainly conservation and reconstruction work. However, the western facade still awaited further redesign. **[11]**

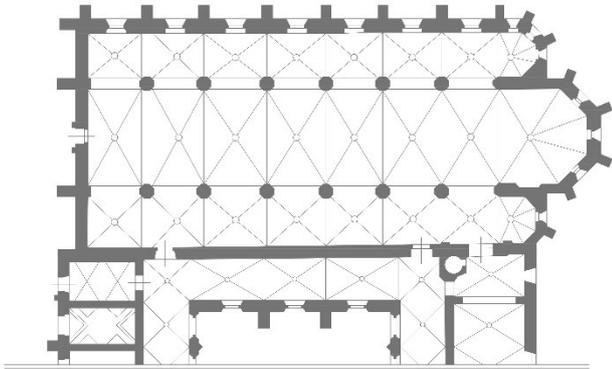
Figure 14: Floor plan, the current state of The Emmaus Church in Prague, Czech Republic. Redrawn by Martina Jelínková

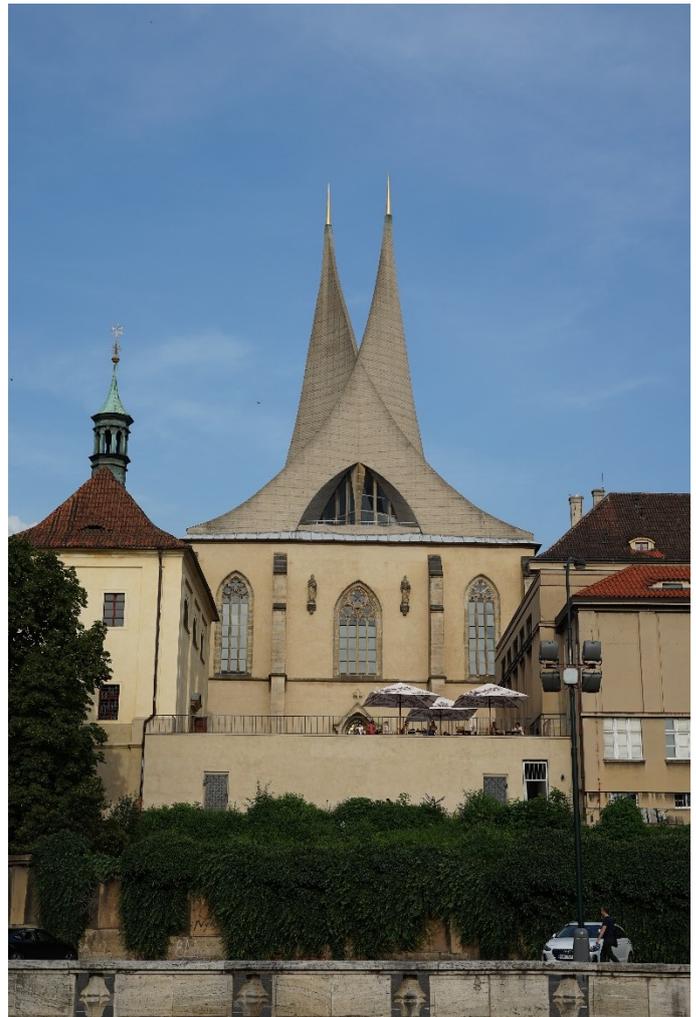
Figure 16: The current state of The Emmaus Church in Prague, Czech Republic. Author: Martina Jelínková

The design of the restoration of the church facade was dealt with by several architects, mainly due to changes in the general design companies in charge of the restoration. All the opinions that were presented were based on the latest preserved state, i.e. the Beuron pseudo-Gothic rebuilding, but none of the designs involved an exact reconstruction of the towers. The conviction that the completion of the towers should be carried out in a contemporary architectural fashion thus became a growing opinion in the professional public. Finally, in 1964, an architectural competition was announced for the completion of church towers. From the six submitted proposals, the expert jury unanimously selected the design of the architect František

Maria Černý, which comprised an indicative reconstruction of the towers in a significantly artistic way and at the same time allowed the release of the western vaulted field. (Fig. 16) In addition, with his design of the contrasting styling of the proposed towers, F. M. Černý supported the original urban concept, which was created in this location during the individual stages of development. [12]
